# Lexus Canada Inc. safety improvement campaign

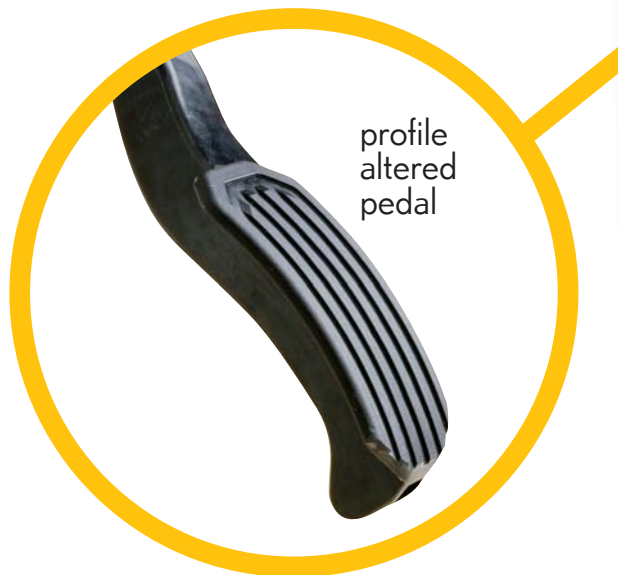
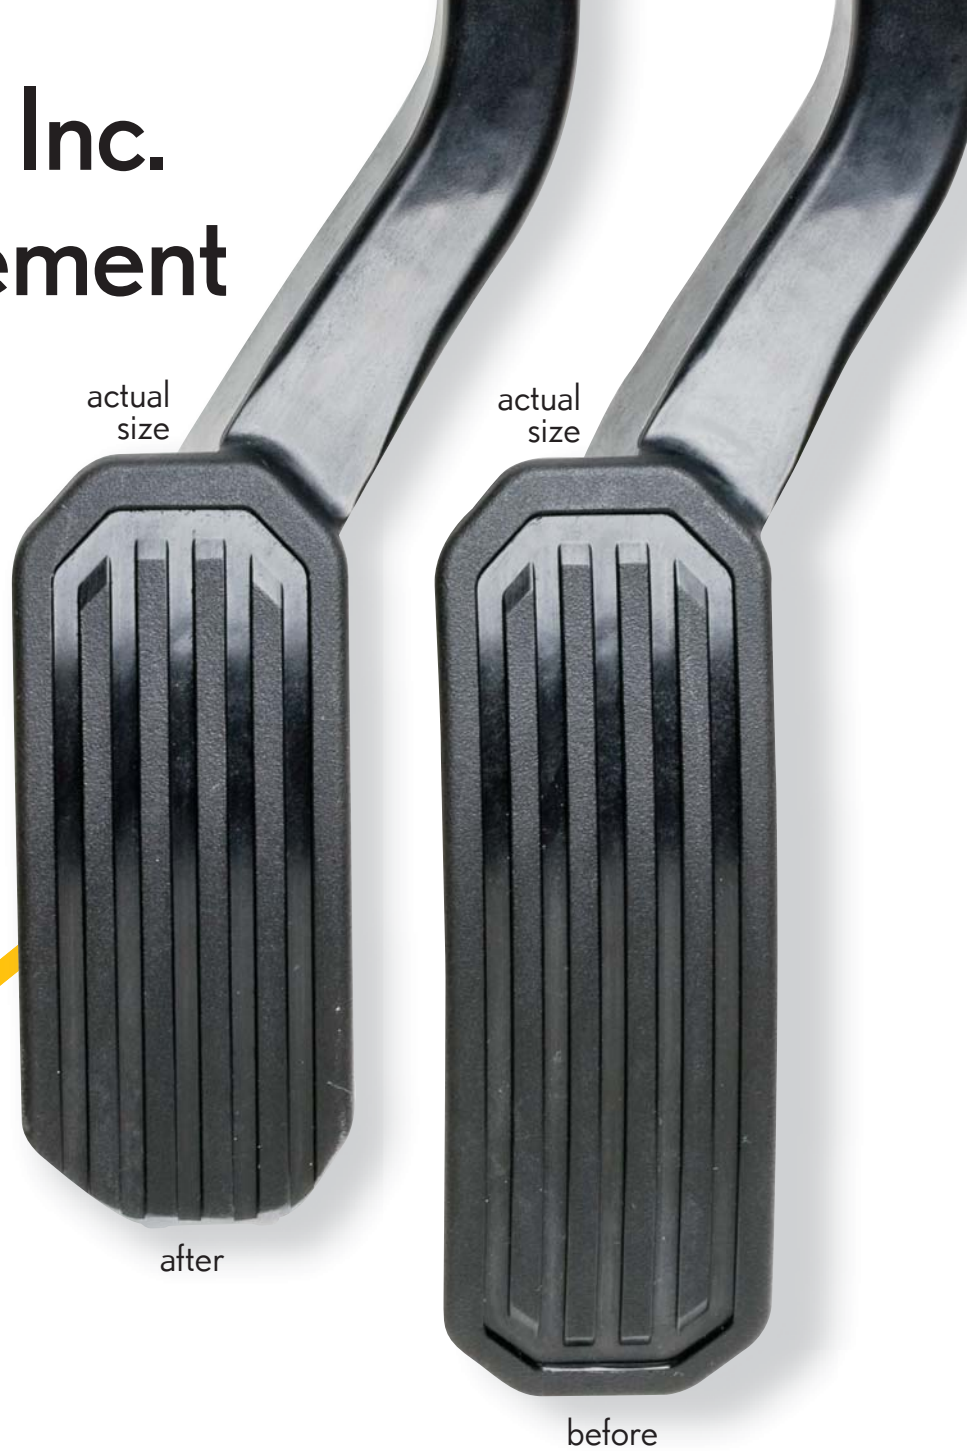
profile  
altered  
pedal

actual  
size

after

before

Lexus will reconfigure (reshape) the accelerator pedal (as shown). 20 millimetres of material will be removed from the bottom of the accelerator pedal, increase the distance between floor carpet and accelerator pedal which will reduce the potential risk for accelerator pedal entrapment or interference from an unsecured or incompatible driver's side floor mat.

- 1) Reconfiguration of the accelerator pedal for the affected models<sup>1</sup>
- 2) Reconfiguration of the shape of the floor surface to increase the space between the accelerator pedal and the floor for certain models<sup>2</sup>
- 3) As an extra measure of confidence, install a brake override system for the certain models<sup>3</sup>
