Lexus Canada Inc. safety improvement campaign

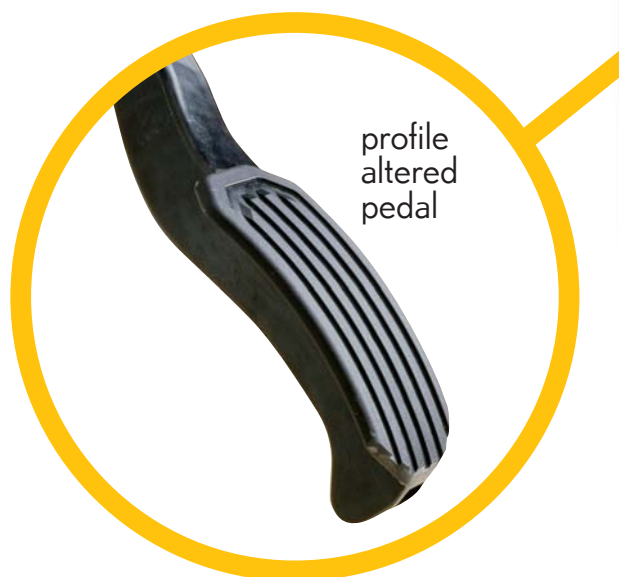
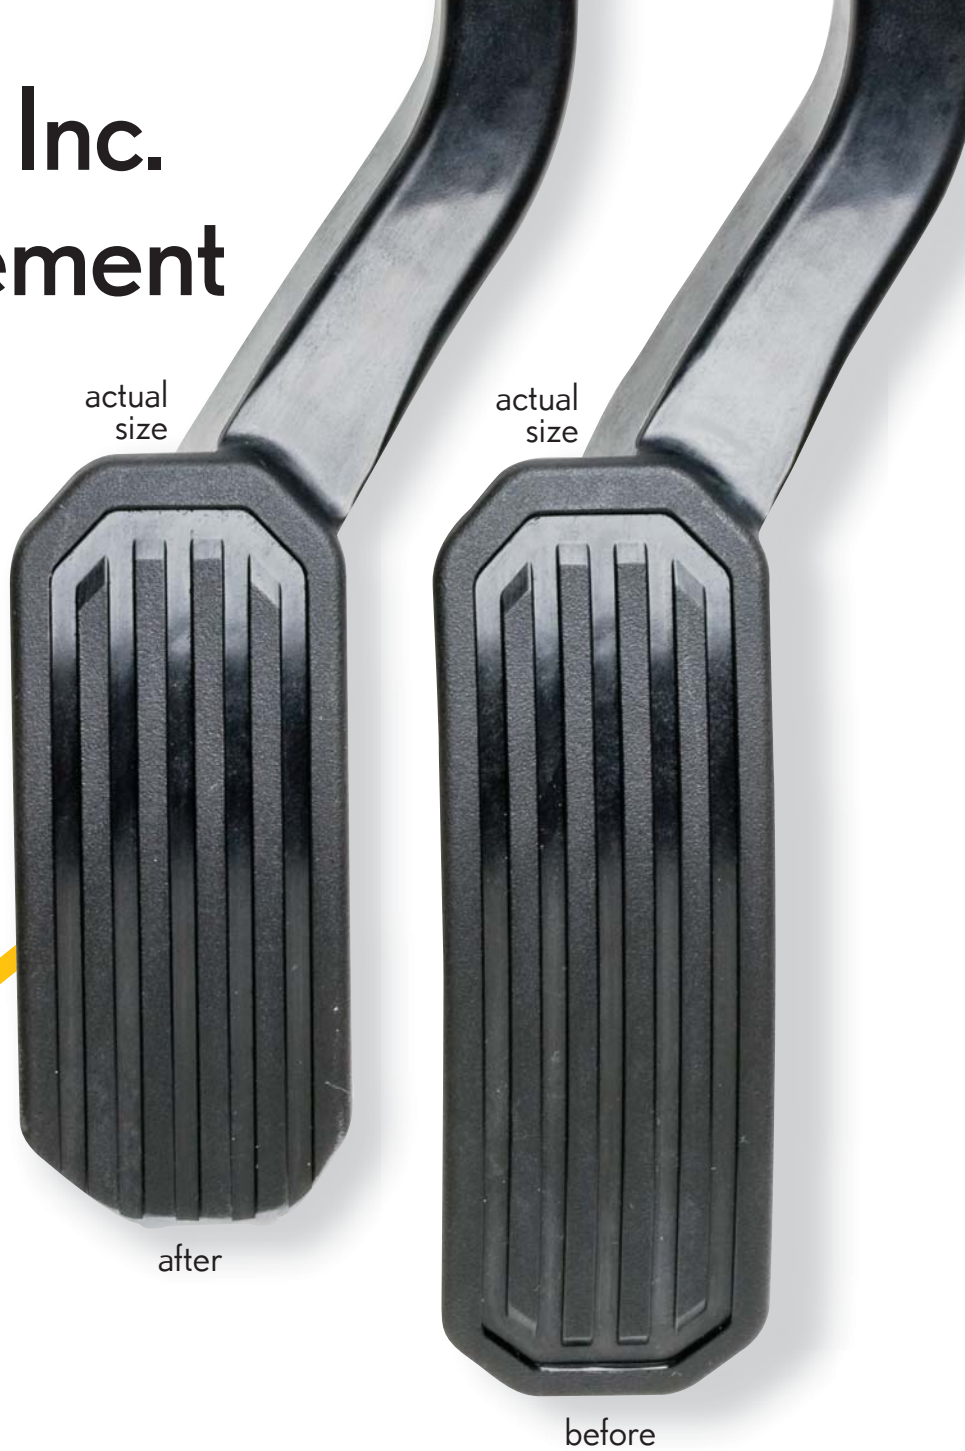
Lexus will reconfigure (reshape) the accelerator pedal (as shown). 20 millimetres of material will be removed from the bottom of the accelerator pedal, increase the distance between floor carpet and accelerator pedal which will reduce the potential risk for accelerator pedal entrapment or interference from an unsecured or incompatible driver's side floor mat.

- 1) Reconfiguration of the accelerator pedal for the affected models¹
- 2) Reconfiguration of the shape of the floor surface to increase the space between the accelerator pedal and the floor for certain models²
- 3) As an extra measure of confidence, install a brake override system for the certain models³
